REVEGETATION AND SELECTED TERRAIN DISTURBANCES ALONG  
THE TRANS-ALASKA PIPELINE 1975-1978(U) COLD REGIONS  
RESEARCH AND ENGINEERING LAB HANOVER NH L A JOHNSON  
JUN 81 CRREL-81-12 F/G 6/6

## *Revegetation and selected terrain disturbances along the trans-Alaska pipeline, 1975-1978*

Lawrence A. Johnson

June 1981

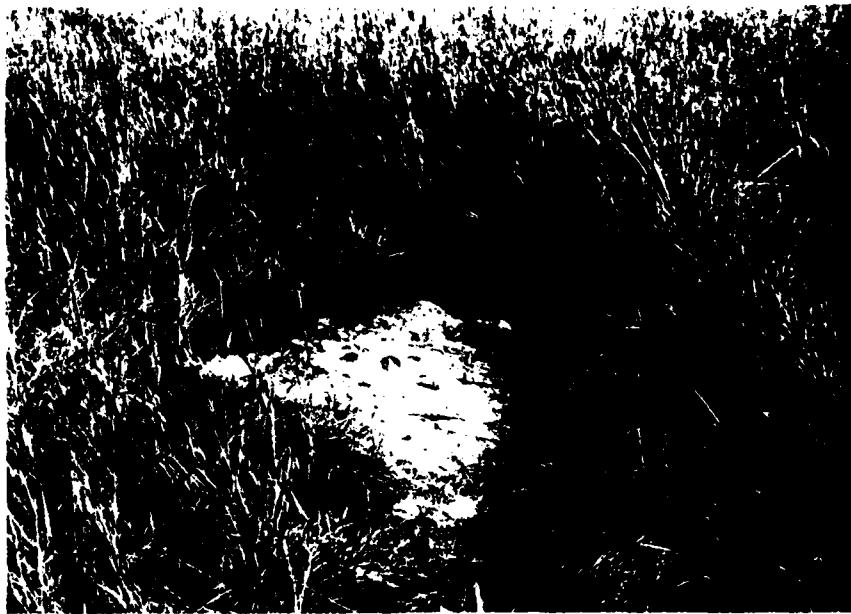
9. *Application rates.* Despite the extensive preparation of field manuals by Alyeska, work crews did not always strictly follow the stated methods. Seeding and fertilizer applications occasionally varied due to inadequate instructions to workers or to lack of fertilizer and seed rate check boards. Clods of fertilizer were observed at a number of locations during 1977 and 1978, probably because the fertilizer had absorbed water and hardened during several years of storage (Fig. 11).

*Figure 11. Clumped distribution of fertilizer, note increased growth around edges of fertilizer clod. 14 August 1978.*

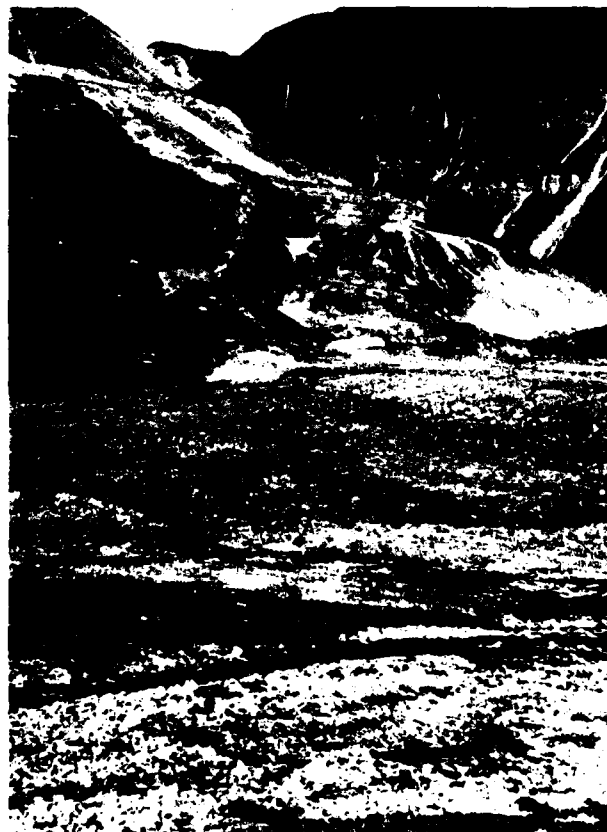
10. *Atigun Pass.* This area poses perhaps the ultimate challenge to biological methods of erosion control along the entire pipeline route. The cold, abbreviated growing season conditions (Brown and Berg 1980) allow only minimal plant growth. Rocky soils with a low percentage of fines (see comment 16 below) further limit growth. The workpad in this area was seeded during 1977 and by the end of 1978 there was

*Figure 12. Reseeded workpad on north side of Atigun Pass (14 August 1978)*

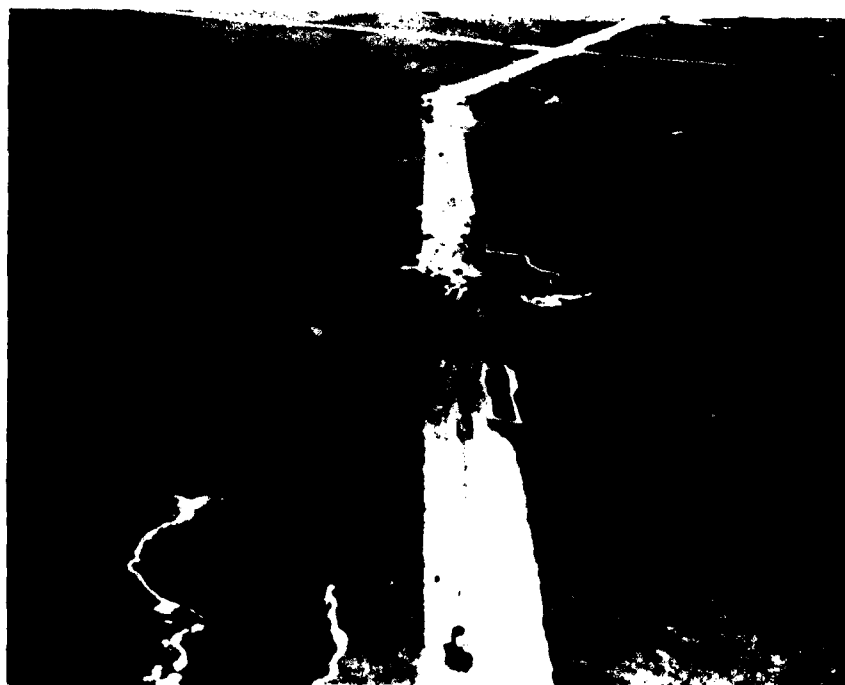
*Figure 60. Aerial view of valve 7 crude oil spill. Note fanning out of spray downwind. (Photograph courtesy of Joint Fish and Wildlife Advisory Team, July 1977).*
